Draft Chazy Lake Management Plan

July 2020

Prepared by the Lake Champlain Lake George Regional Planning Board for the Chazy Lake Watershed Initiative, with funding assistance from NYSDEC through the Environmental Protection Fund (EPF).

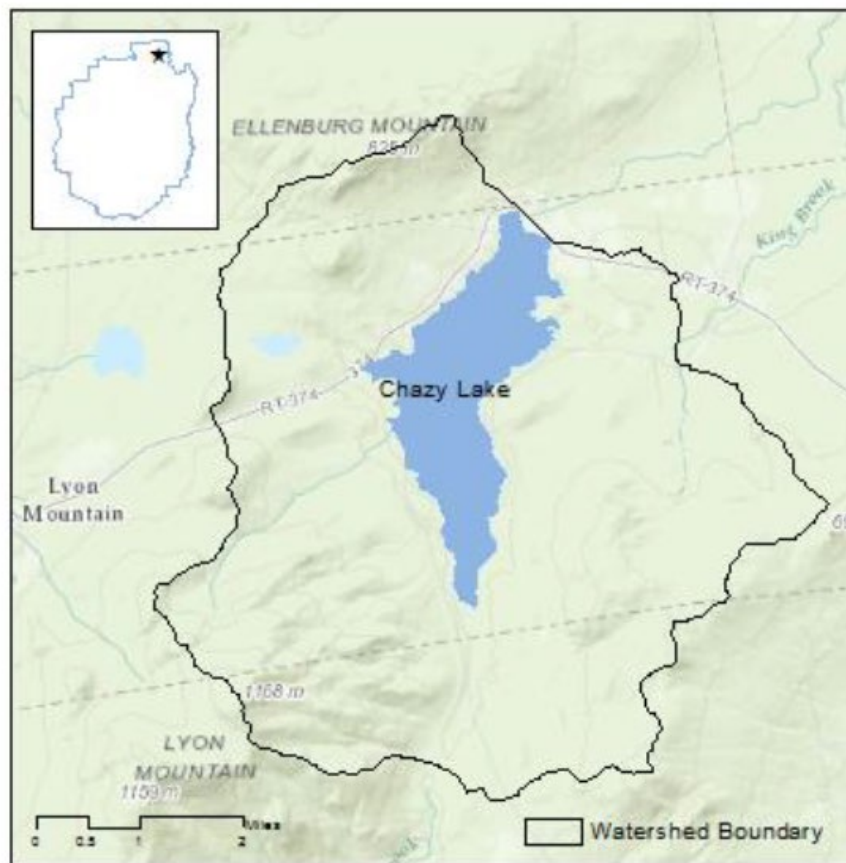
Figure 1: Chazy Lake and Watershed Boundary.

The watershed of Chazy Lake lies in the Adirondack Mountains and is in part of the Lake Champlain Basin and the Great Chazy River Watershed sub-basin. The lake's watershed is 14,085 acres and is steeply sloping with elevations ranging from 1,541 at the lake's surface to 3,830 feet above sea level at

the summit of Lyon Mountain. The lake has a surface area of 1,606 acres and a steeply sloping watershed of 14,085 acres. The maximum depth is 21.9 meters (72 feet) and the mean depth is 10.1 meters (33 feet). The bottom of Chazy Lake slopes rapidly away from the shoreline in most places, providing limited areas for the growth of aquatic plants.

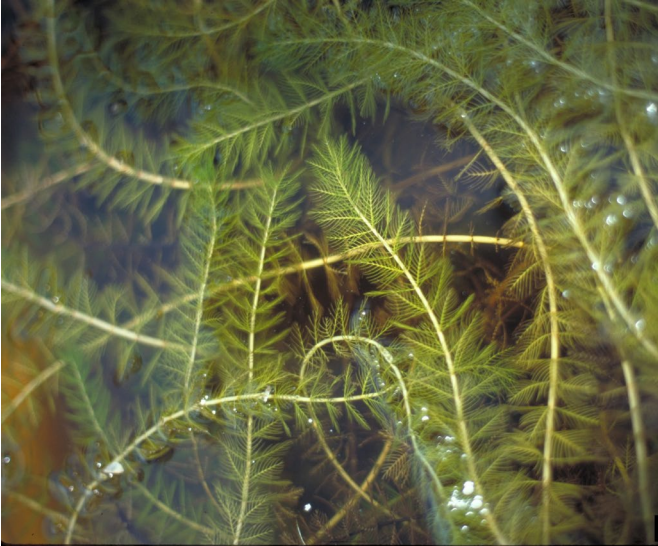
Photo 6: Eurasian watermilfoil is found in areas throughout Chazy Lake. Photo Source: Lake George Association.

In 2006, the Adirondack Park Invasive Plant Program (APIPP) identified Eurasian watermilfoil (*Myriophyllum spicatum* L) in Chazy Lake. Shoreline surveys by volunteers identified extensive growth of Eurasian watermilfoil throughout the lake, with dense growth at the south end of the lake and in one cove on the west side. Surveys performed by the Darrin Fresh Water Institute in 2008 and 2012

confirmed extensive growth, most notable at the north and south ends of the lake and in coves on the east and west shore.

In an effort to control the Eurasian watermilfoil present in Chazy Lake, the Town of Dannemora utilizes the dam to lower the lake by 2.5 feet every 3 years. A lake level drawdown has occurred in the winters of 2011-2012, 2014-2015, and 2017-2018. After each drawdown, the Darrin Fresh Water Institute conducts a vegetative survey to make sure the method is working. The surveys have concluded that the drawdowns are working, and the quantity of shallow-water milfoil has been reduced by this method without negatively impacting native vegetative species. Deep-water milfoil continues to thrive, however,

because the current drawdown level only effects milfoil at a depth of up to 5.5 feet.

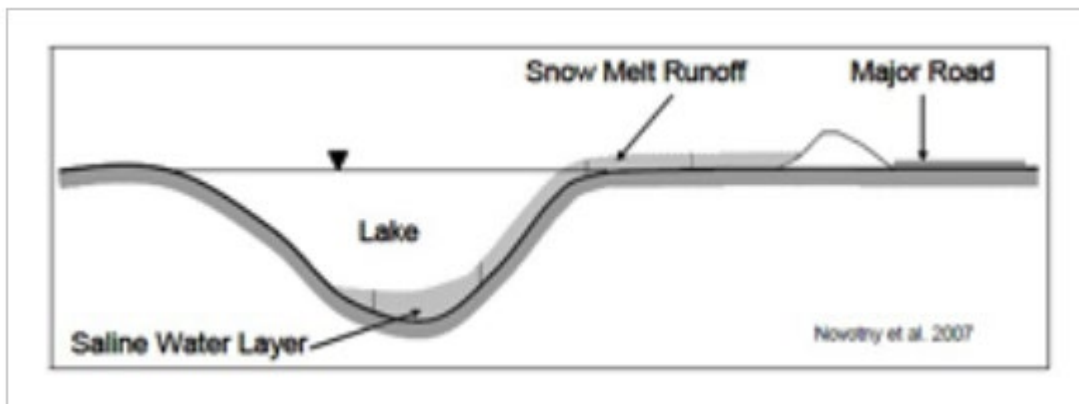
Figure 3: Process by which road salt enters a waterbody. Source: New Hampshire Department of Environmental Services

Road salt can have direct and indirect effects on aquatic ecosystems and can also negatively impact drinking water supplies by seeping through the soil into household wells. Contaminants from road salt enter water resources by infiltration to groundwater, runoff to surface water and through storm drains. Water contaminated with road salt will have a higher density and will settle in the deepest part of the waterbody, this can lead to a chemical stratification which can impede turnover and mixing, preventing the dissolved oxygen within the upper layers of the water from reaching the bottom layers and nutrients

within the bottom layers from reaching the top layers. This leads to the bottom layer of the waterbody becoming void of oxygen and unable to support aquatic life.
